## **Durable Hydrophobic Surface Treatment for Enhanced Corrosion Protection**

### **Small Business Innovation Research (SBIR) Grants for branches of US Military**

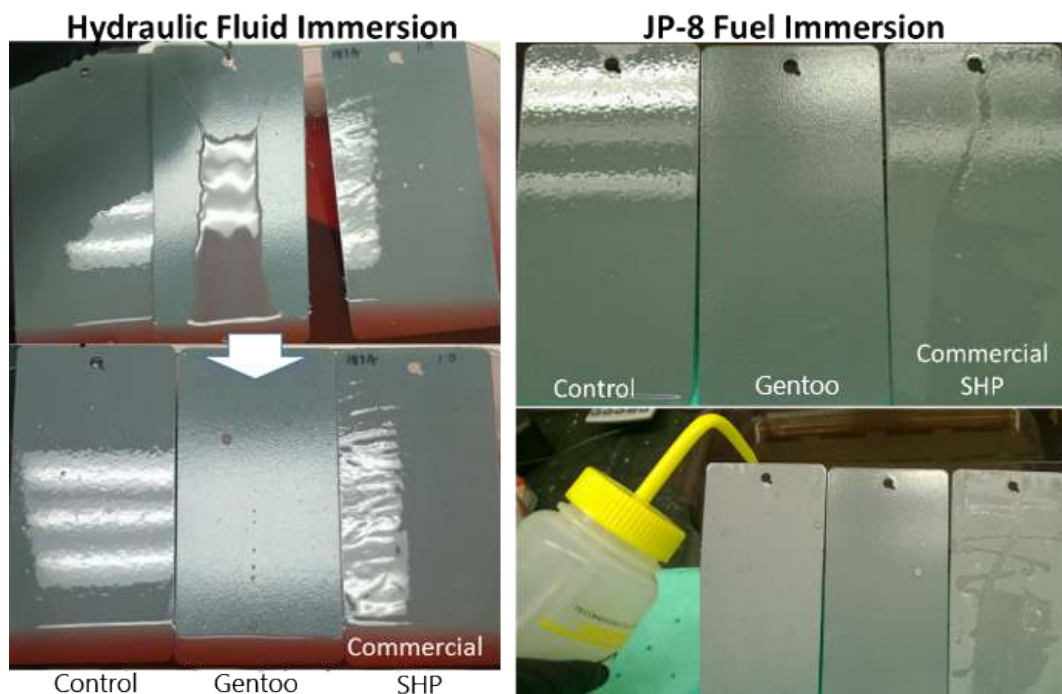
**Figure 1**

Fluid Immersion assessment of MIL-PRF-23377 Primer with MIL-PRF-85285D Topcoat painted aluminum panels untreated (control), Gentoo-treated, and commercial SHP treated in Hydraulic fluid at 66°C for 24 hours (Left) and JP-8 at room temperature for 7 days followed by an isopropanol rinse (Right)

Gentoo demonstrated no blistering or coating defects and maintained hydrophobic performance following immersion in aircraft deicing fluid, cleaning compound (degreaser), lubricating oil, hydraulic fluid and JP-8 fuel. The Gentoo was removed using the PR-3500 epoxy paint remover, as expected. Commercially available superhydrophobic (SHP) paint was also assessed, and that coating lost all superhydrophobic and hydrophobic performance after immersion in all fluids, and was completely removed when immersed in most fluids, except deicing fluids. Figure 1 exhibits some representative images.

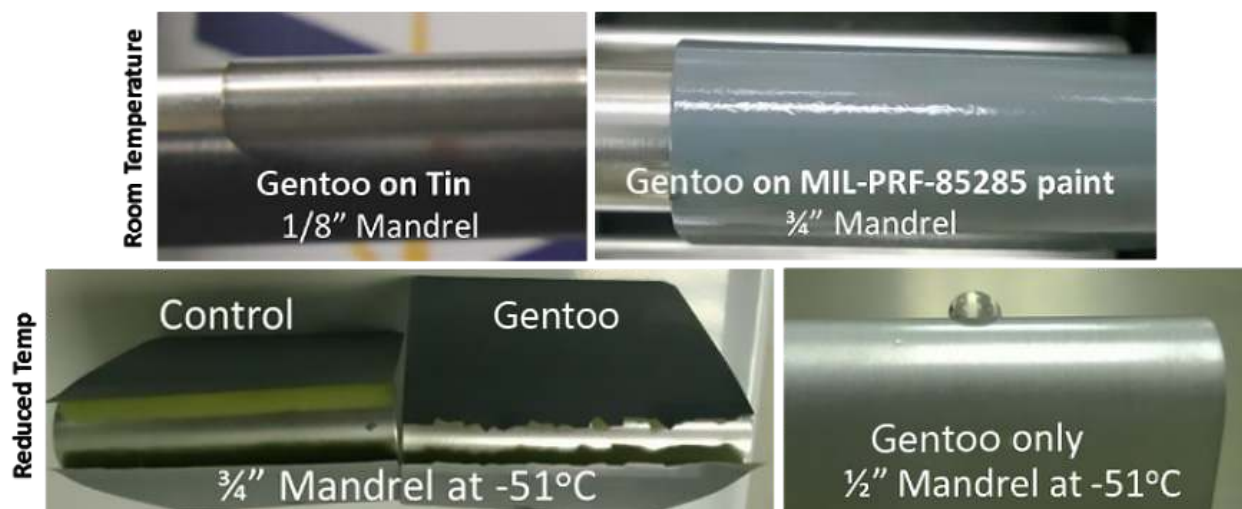
**Figure 2**

Mandrel Bend Flexibility of Gentoo Treatment at Room Temperature direct to metal and on MIL-PRF-85285 grey urethane topcoat (Top Row) and -51°C on MIL-PRF-85285 grey urethane topcoat (Bottom Row)

Gentoo exhibits excellent flexibility at room and low temperatures (Figure 2). Gentoo at -51°C bent over a 3/4 inch mandrel cracked during low temperature flexibility assessment, but failure of the primer - aluminum panel interface resulted in complete coating failure. The Gentoo was not the source of the failure and the ragged edges are indicative of the Gentoo attempting to keep the coating system together despite the delamination event. An aluminum panel coated only with Gentoo was reevaluated at -51°C and passed 1/2 inch mandrel bend. Hydrophobic performance of the Gentoo retained as evident by the water drop on the tested surface.

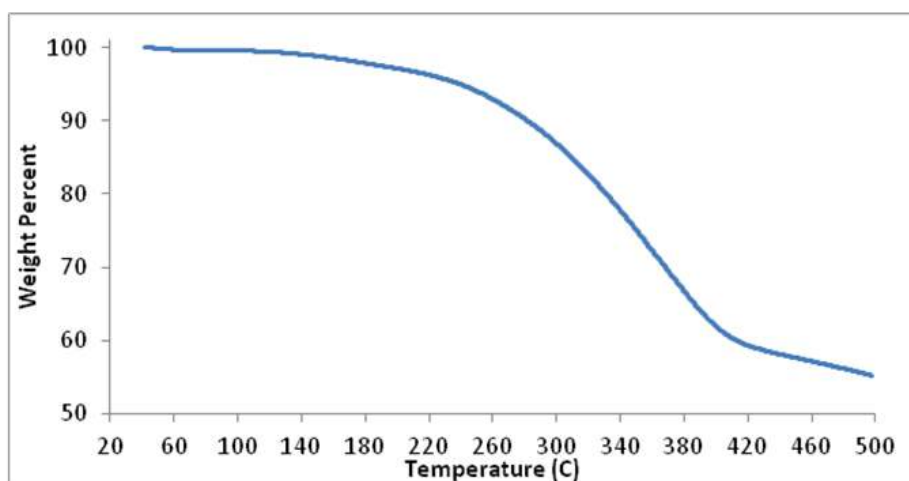
**Figure 3**

Decomposition TGA of cured, Gentoo formulation (ramp rate of 3°C/minutes)

Gentoo is stable up to 200°C according to Figure 3 TGA decomposition curve. Thus, the coating has a wide range of operating temperatures from -51 to 200°C.; however, for continuous use (as opposed to temperature spikes) we recommend a maximum operating temperature of 160°C

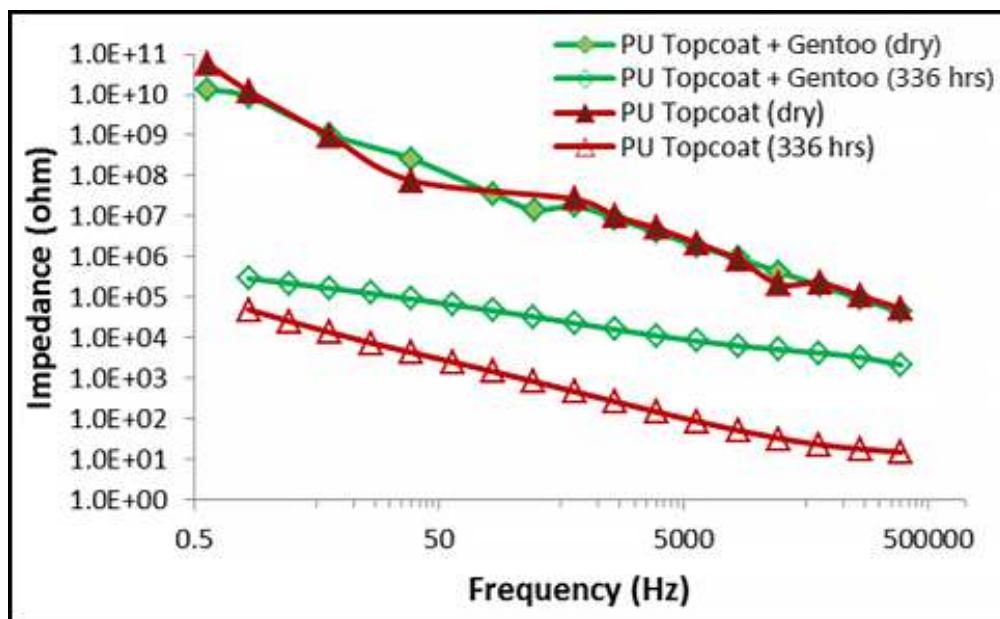
**Figure 4**

Electrochemical Impedance Spectroscopy (EIS) testing: MIL-PRF-85285D Polyurethane coated UNSA92024 aluminum alloy.

Electrochemical Impedance Spectroscopy (EIS) was used to evaluate the barrier properties of the Gentoo coating. Aluminum alloy UNSA92024 coupons were coated with MIL-PRF-85285D grey polyurethane (1.0 mil thick) and tested with and without the addition of Gentoo. Initial testing (i.e. "dry") of the samples showed similar impedance across the full frequency range (Figure 4). After exposure to ASTM B117 salt fog conditions for 336 hours, the samples were retested. The polyurethane only sample showed a significantly larger reduction in impedance (~two decades) compared to the Gentoo, indicating significantly better barrier properties for the coupon.

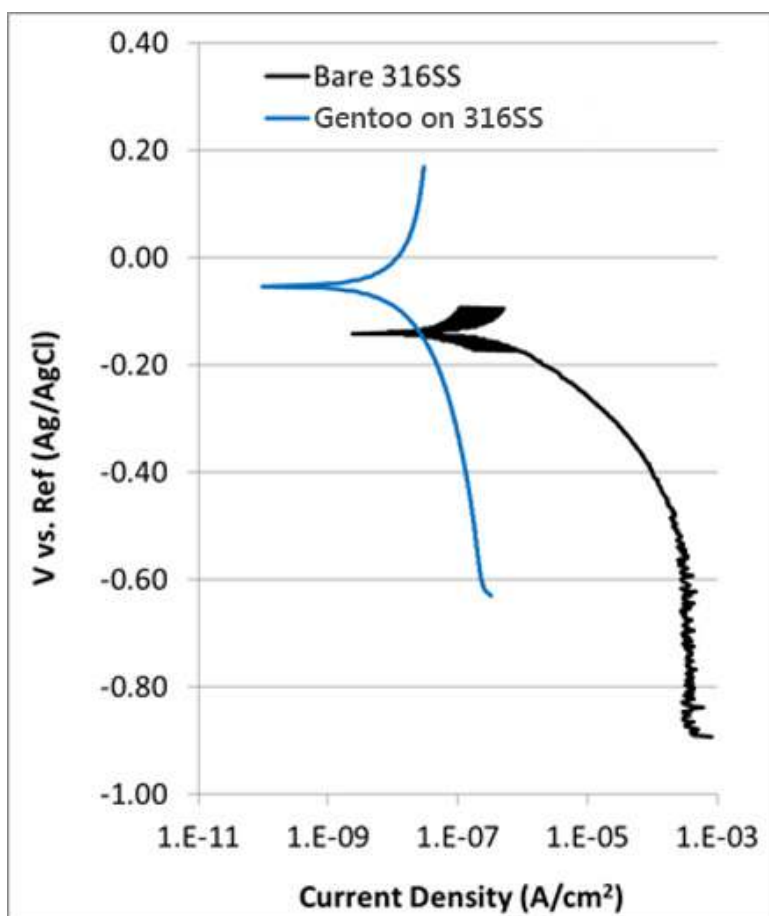
**Figure 5**

Polarization test results for a bare 316 stainless steel substrate compared to a similar substrate with Gentoo.

Galvanic corrosion around cathodic fasteners mated to anodic aluminum alloy structures is a common problem in the aircraft community. It is known that galvanic corrosion of aluminum is controlled by the available cathodic current, and that a reduction in available current should result in less corrosion damage. As an assessment of the possible galvanic protection attributes of Gentoo, polarization testing was conducted on a bare 316 stainless steel flat coupon and compared to a similar coupon with Gentoo applied. Results from the tests are observed in Figure 5. The addition of Gentoo resulted in an approximate two-order of magnitude reduction in cathodic current density compared to the bare 316 stainless steel coupon.

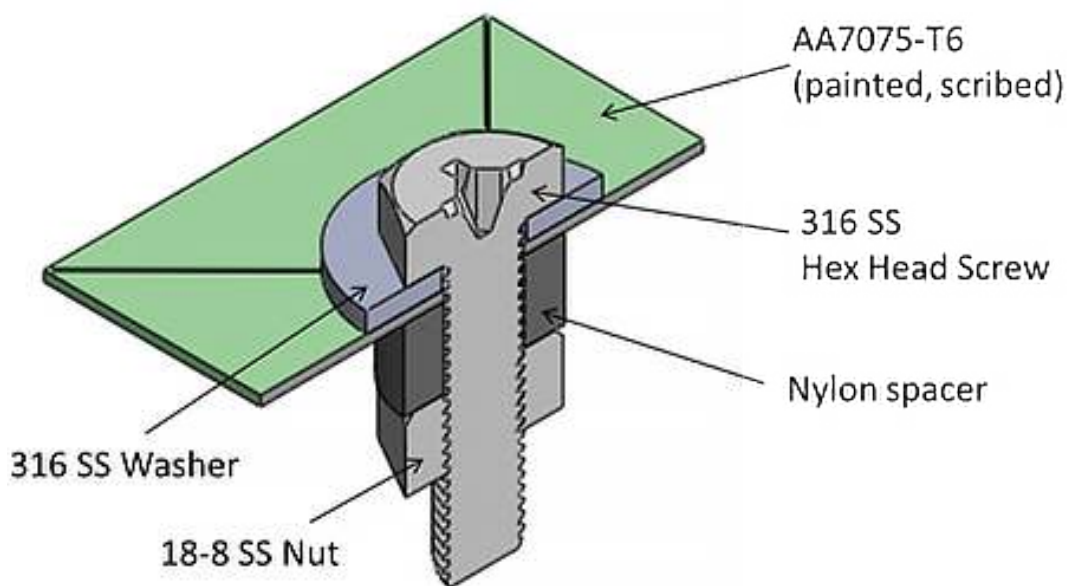
**Figure 6**

Schematic overview of the galvanic fastener assembly components used for corrosion assessment of Gentoo as applied to 316 stainless steel fasteners.

As a further assessment, several 316 stainless steel screws and washer assemblies were prepared bare, and separately coated with Gentoo. The fasteners were attached to primed and topcoated aluminum alloy 7075-T6 (UNS A97075) coupons and exposed to accelerated corrosion conditions for galvanic corrosion assessment. Specifically, the fastener assemblies consisted of ¼-20 x 1 inch full-thread screws and corresponding mated flat washers (Figure 6), with and without Gentoo. Select screws and washers were also cadmium plated per ASTM F1941 FE/CD 5A. The 7075-T6 aluminum coupons were approximately 1 x 1.375 x 0.032 inch and a ¼-20 drill and tapped hole was created in the middle region of each one for mated fastener attachment. All aluminum panels were initially deoxidized with Alumiprep 33 and treated with PreKoke, a non-chromate adhesion promoter for paints. Following

the pretreatment, a MIL-PRF-23377 epoxy primer and MIL-PRF-85285D grey polyurethane topcoat from PRC Desoto were applied to the surface. The coated coupons were hand-scribed to expose fresh, bare metal prior to fastener attachment. During galvanic assembly, nylon spacers and 18-8 stainless steel nuts were used on the backside of the aluminum coupons and torqued to 25 in-lbs. Each distinct assembly type was tested in triplicate via placement in ASTM B117 cyclic salt fog conditions.

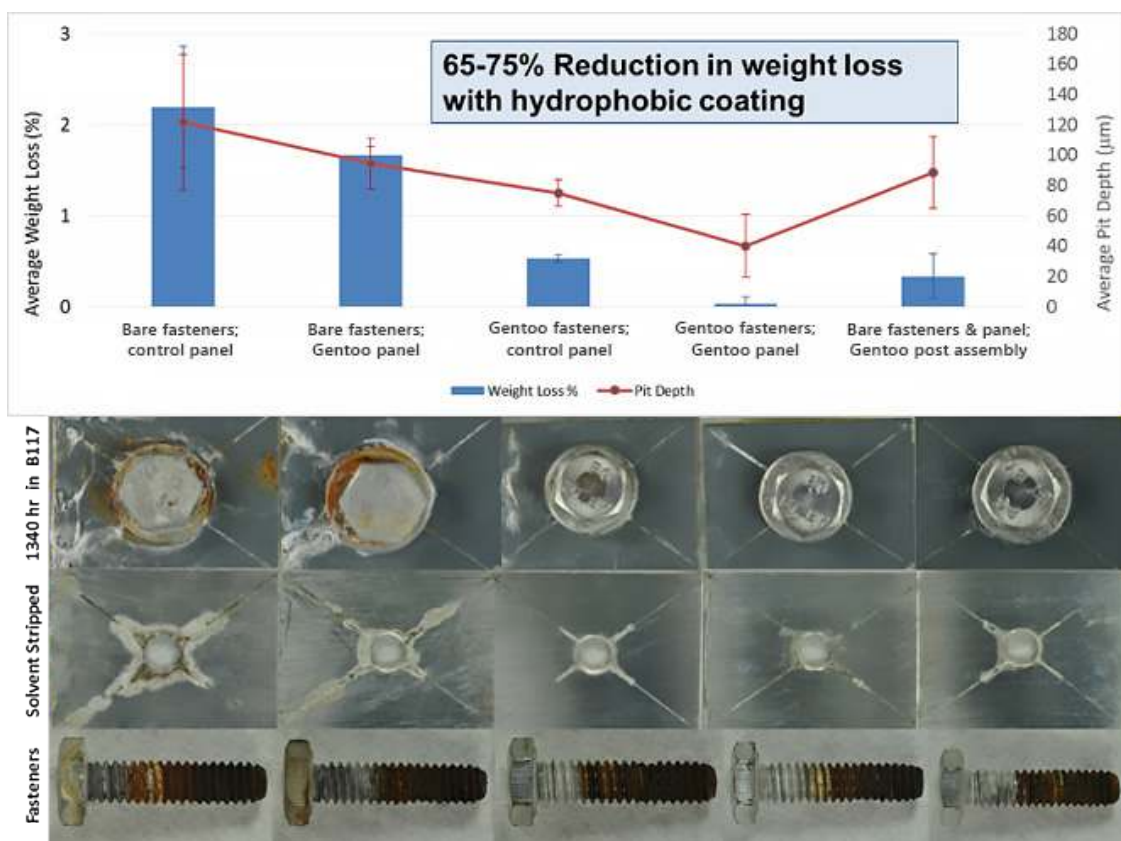
**Figure 7**

Galvanic Fastener Assembly Test Images of Cadmium plated B7 HSS bolts after 1340 hours of Salt Spray (top row images) and solvent stripped using ASTM G1, coated 7076-T6 aluminum panels (middle row) measured for weight loss and pit depth (accompanied graphs), and side images of representative fasteners (bottom row)

Bare B7 steel fastener and cadmium (Cd) plated B7 steel fastener assemblies were used for galvanic coupling with the scribed, painted aluminum panels. Control and Gentoo coated fastener assemblies were used. After 648 hours of B117 exposure, significant amounts of corrosion product was evident with the bare B7 steel fastener assemblies, while significantly less corrosion was evident after 1340 hours of salt spray with the cadmium plated B7 steel fasteners. The test assemblies were removed from B117, solvent stripped and cleaned using ASTM G1 guidelines and evaluated for weight loss and pit depth measurements due to corrosion. The parts were solvent stripped by first using a Rust-Oleum Aircraft Paint Remover soak at 49°C, followed by immersion in a 60-70% nitric acid stripping solution and rinsed with ethanol to remove any residue. Improved corrosion resistance from Gentoo treatment of

fasteners and painted panels were demonstrated visually, by corrosion based weight loss and pit depth measurements of the stripped aluminum panels on both the bare B7 and cadmium plated B7 fastener assemblies. The barrier effect of the Gentoo appears to be potentiated when combined with electrochemically deposited layers, such as Cd plating. Results are displayed in Figure 7.

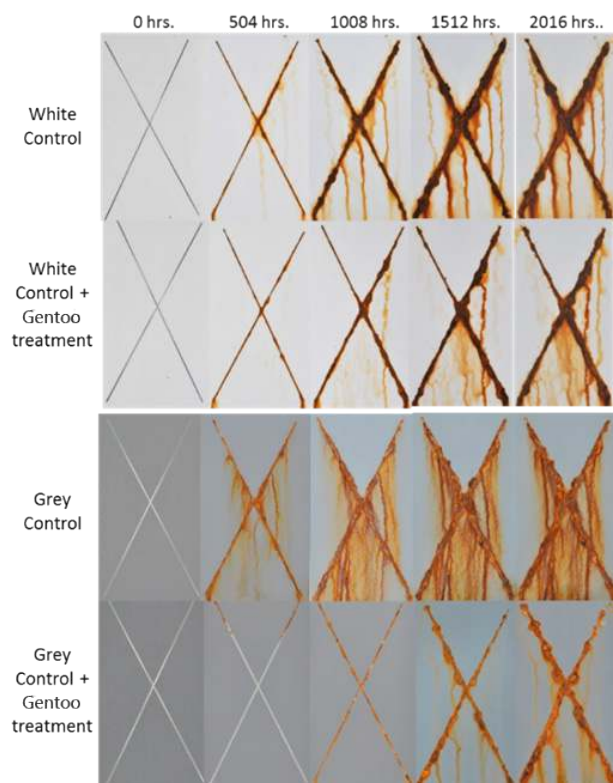
**Figure 8**

Images of MIL-PRF-32239 scribed LHE Zn-Ni 4130 HSS painted panels with either the MIL-PRF-85285 white glossy topcoat or the MIL-PRF-85285 grey semi-gloss topcoat with and without Gentoo following ASTM B117 Salt Fog Exposure

Accelerated ASTM B117 corrosion testing was performed on LHE Zn-Ni plated 4130 HSS painted panels. The flat panels were primed with a MIL-PRF-85582 Class N chrome-free epoxy primer and topcoated with a CA8201/F17925 MIL-PRF-85285 Type I Class H white glossy urethane paint, or a CA8211/F3673 MIL-PRF-85285E Type I grey semi-gloss paint. Control panels included the primer and topcoats only. Gentoo was applied to selected control panels. All panels were "X" scribed according to MIL-PRF-32239 and placed in ASTM B117 salt fog with images taken every 500 h. Figure 8 displays the salt fog exposed panel images for the white and grey topcoat controls and Gentoo treated panels. Significant amounts of red rust are present on all the panels with the onset of rust by 500 h of exposure. The scribe corrosion is rated according to ASTM D1654 for each of the panels and is graphically displayed in Figure 9. For both the white and grey topcoats, the Gentoo treatment significantly reduces the scribe creep.

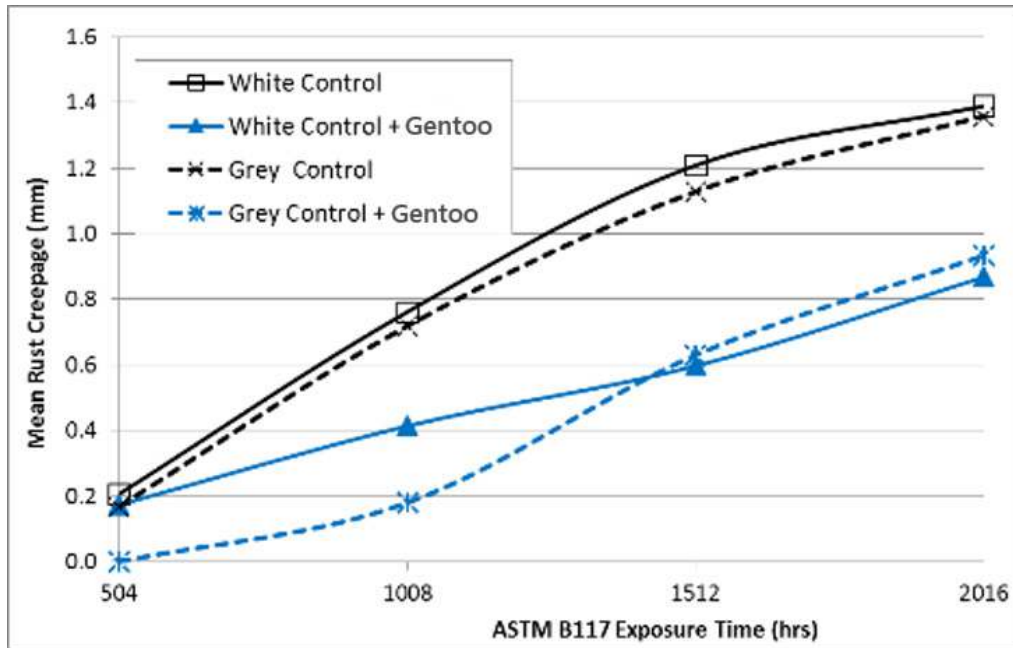
**Figure 9**

ASTM D1654 Scribe Corrosion Ratings of Scribed, ASTM B117 Salt Fog Exposed painted, LHE Zn-Ni 4130 HSS panels with and without Gentoo

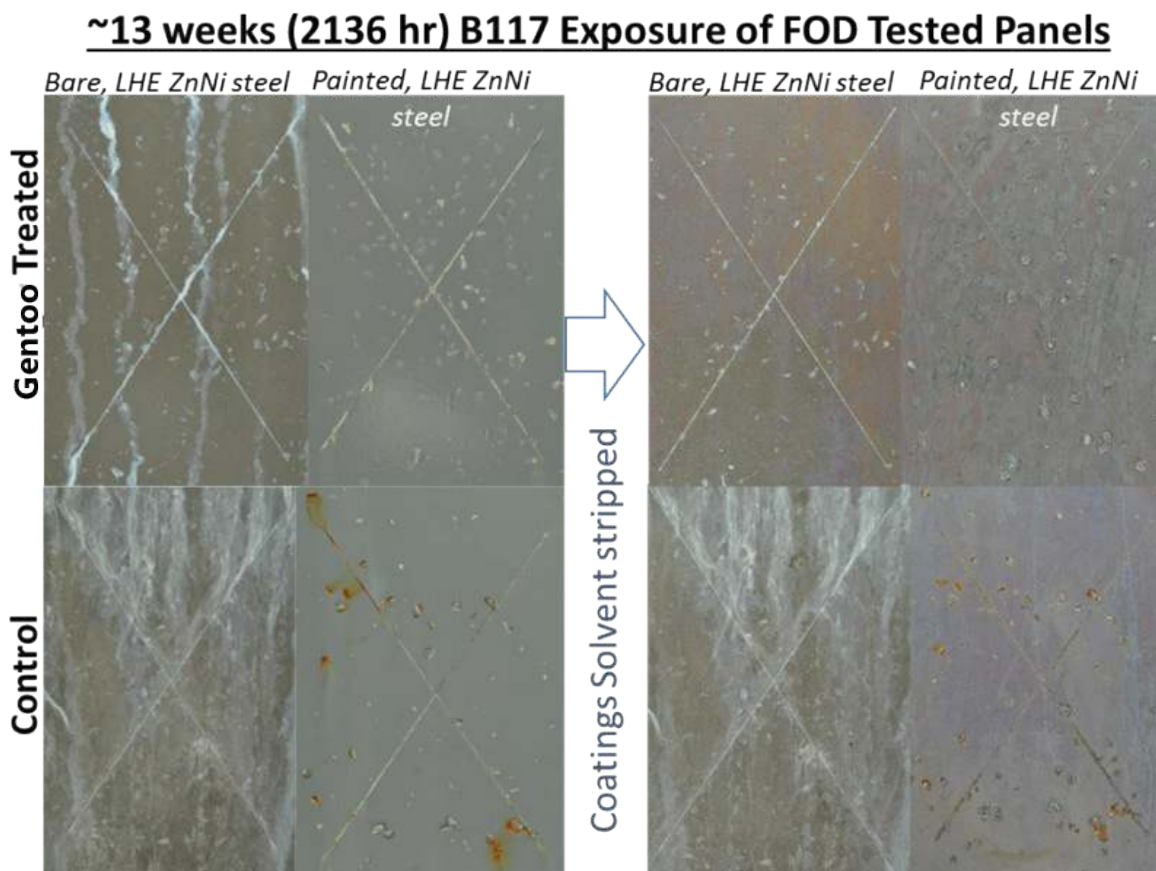
**Figure 10**

2136 hours of B117 Salt Fog Exposure of FOD Tested Bare and MIL-PRF-23377 primer with MIL-PRF-85285D topcoat painted LHE Zn-Ni plated HSS panels with and without Gentoo

UDRI performed chipping resistance testing on Gentoo treated and untreated LHE Zn-Ni 4130 steel panels, as well as on Gentoo treated and control MIL-PRF-23377 epoxy primer with MIL-PRF-85285D grey urethane topcoat painted LHE Zn-Ni 4130 steel panels. No reportable differences were observed in coating chip protection between the Gentoo treated and untreated bare steel panels. After chipping resistance testing, the damaged panels were placed into an ASTM B117 salt fog chamber. After 2136 hours of exposure, the Gentoo treated steel and Gentoo treated primed/topcoated, steel panels demonstrate significant corrosion improvement over the bare steel and painted steel control panels. This Gentoo treatment is providing added exposure protection as a function of impact over the control panels.

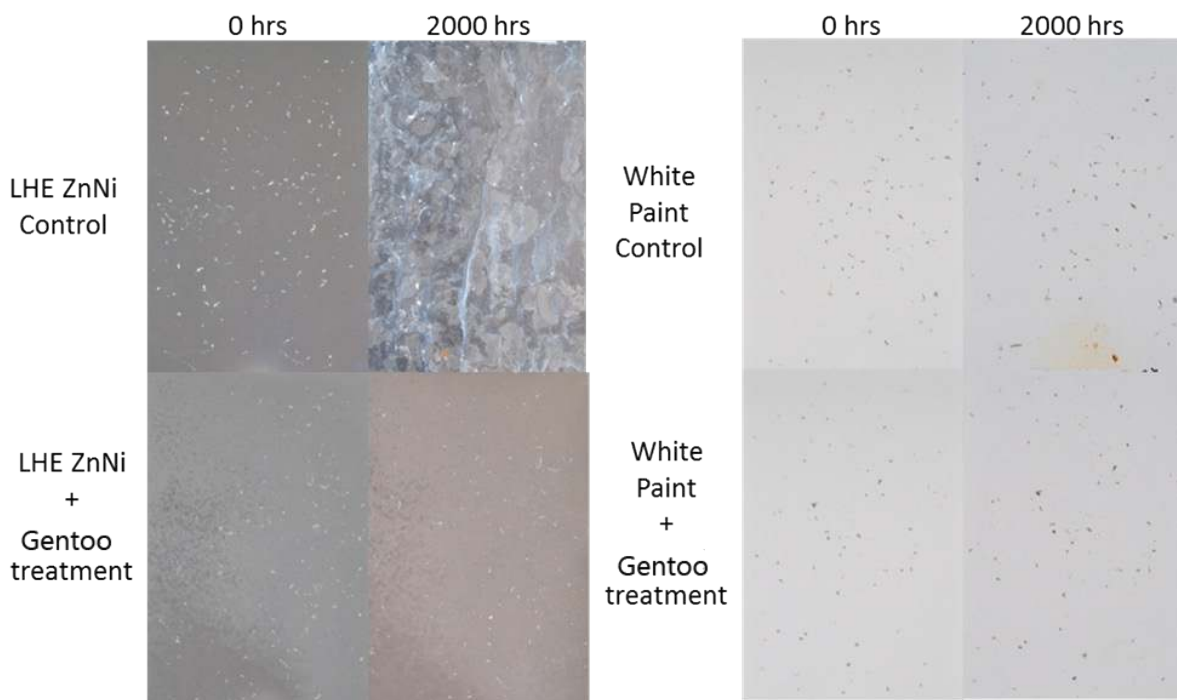
**Figure 11**

ASTM B117 Exposed, Chipping Resistance Tested LHE ZnNi plated 4130 HSS bare and painted panels with and without Gentoo

Chipping resistance testing was repeated with LHE ZnNi plated 4130 HSS panels with a MIL-PRF-23377J Type I Class N chrome-free epoxy primer and topcoated with CA8201/F17925 MIL-PRF-85285 Type I Class H white glossy urethane paint with and without Gentoo. Bare LHE ZnNi 4130 with and Gentoo surface treatment was also included. No significant differences resulted in the chip protection ratings between the surface treated and untreated panels. Panels were placed into ASTM B117 salt fog for 2000 h of exposure. Red rust spots are visible on the painted control panel, while the Gentoo panels remain unchanged (Figure 11).

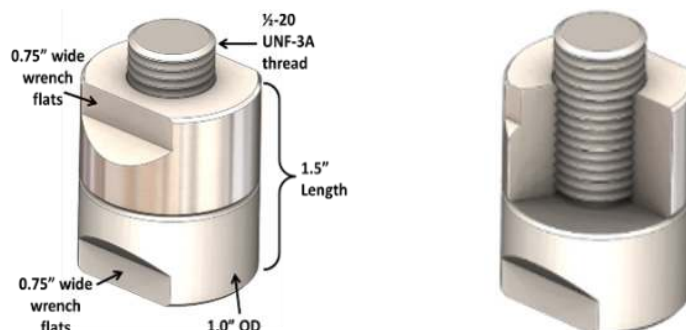
**Figure 12**

Example open-end threaded coupon for accelerated corrosion testing. Material of construction is 300M steel, as well as 7075-T6 aluminum female nuts with 300M male bolts for galvanic assemblies. The flat areas on each end will enable proper torque application. The design intent is to enable moisture ingress through the mated interface perimeter and along the thread interface, which characterize landing gear component configurations

Threaded parts designed to represent a landing gear gland nut assembly were machined 300M steel in an open-end component that is intended to focus corrosion along the male/female threaded interface, as well as the flat interface where the two coupon halves meet. An additional combination using 7075-T6 aluminum female parts mated to a 300M male parts are included in the evaluation, creating a galvanic interface similar to mated surfaces on landing gear wheel assemblies and higher corrosion potential than straight 300M interfaces.

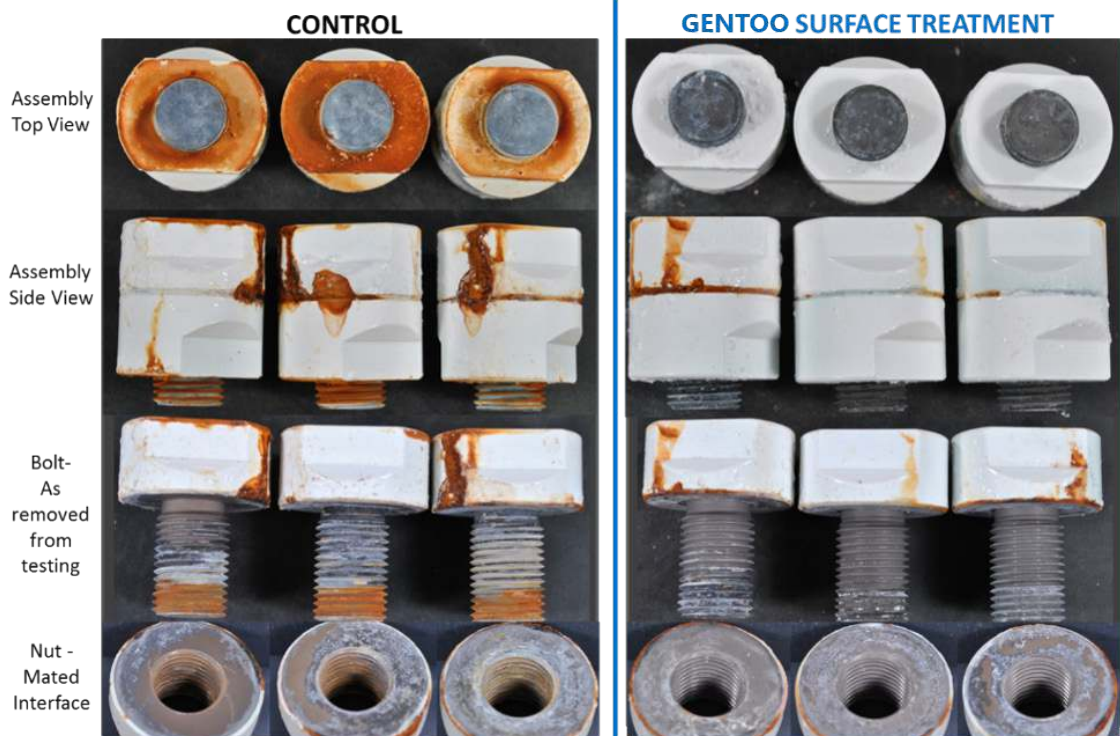
**Figure 13**

5040 h ASTM B117 Exposure of control and Gentoo treated (blue box) LHE Zn-Ni 300M threaded components, as removed from testing

Figure 13 through Figure 15 highlight the differences observed between control and Gentoo treated 300M parts following 5040 h of ASTM B117 salt fog exposure. The parts were removed from testing due to the quantity of red rusting on the exposed threads of the control sample. Upon disassembly, significant amount of corrosion and salt product (white build-up) was found on the unexposed threads of the bolt and nut of the control. The Gentoo treated sample unexposed threads are pristine and shiny on the nut and large sections of the bolt. Following media blasting, the Gentoo treated bolt and nut threads remained a light grey - indicating the undisturbed presence of LHE Zn-Ni (Figure 14). The control bolt's threads are dark and show areas of red rust following media blasting. Similar features are present on the threads of the control nuts (Figure 15). The darkening around the threads indicates that the LHE Zn-Ni plating was completely consumed during testing for both the control bolt and nut threads. The Gentoo provided significantly more protection to the 300M parts in ASTM B117. The USAF specified epoxy primer and urethane topcoat paint system based on their usage. Small blisters erupted on all of the LHE ZnNi 300M threaded parts following a few weeks of accelerated corrosion exposure in both ASTM B117 and GMW 14872. Further investigation revealed an incompatibility between the recommended primer and topcoat systems on LHE ZnNi HSS parts, resulting in blistering. The effects of the blistering are visible as dark spots on the stripped parts (i.e. Figure 15). The blisters were not observed during atmospheric exposure, nor do they appear to affect the corrosion results on the threads of the parts.

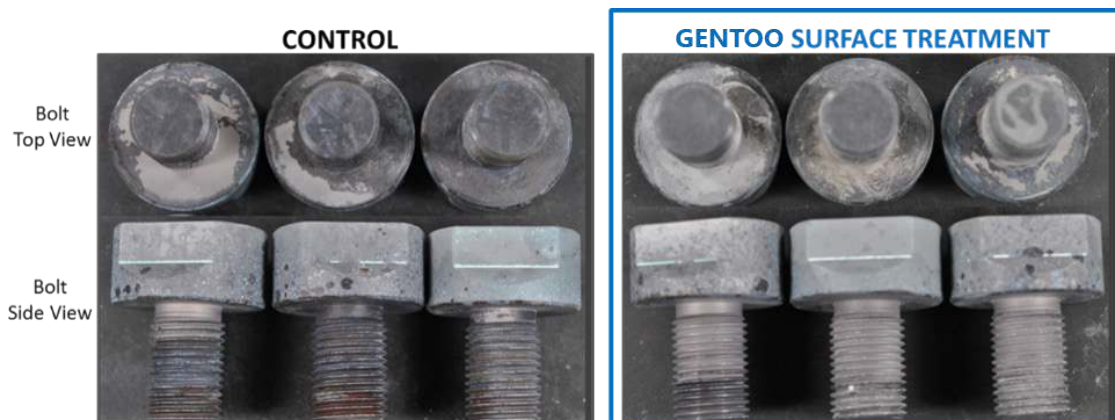
**Figure 14**

Plastic media stripped control and Gentoo treated (blue box) LHE Zn-Ni 300M bolts from 300M assemblies after 5040 h of ASTM B117 exposure

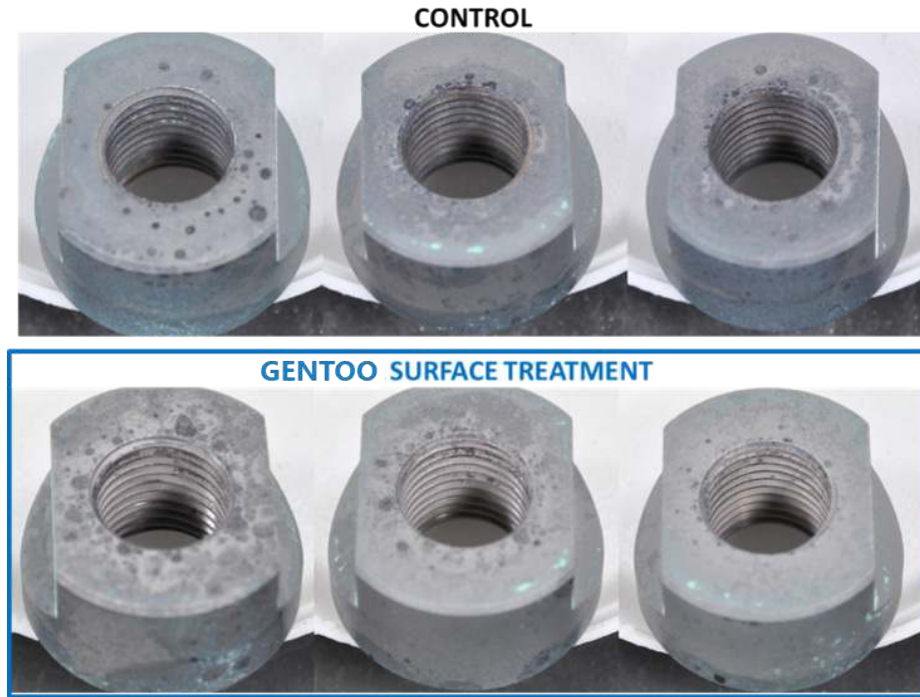
**Figure 15**

Plastic media stripped Control and Gentoo treated (blue box) LHE Zn-Ni 300M nuts from 300M assemblies after 5040 h of ASTM B117 exposure

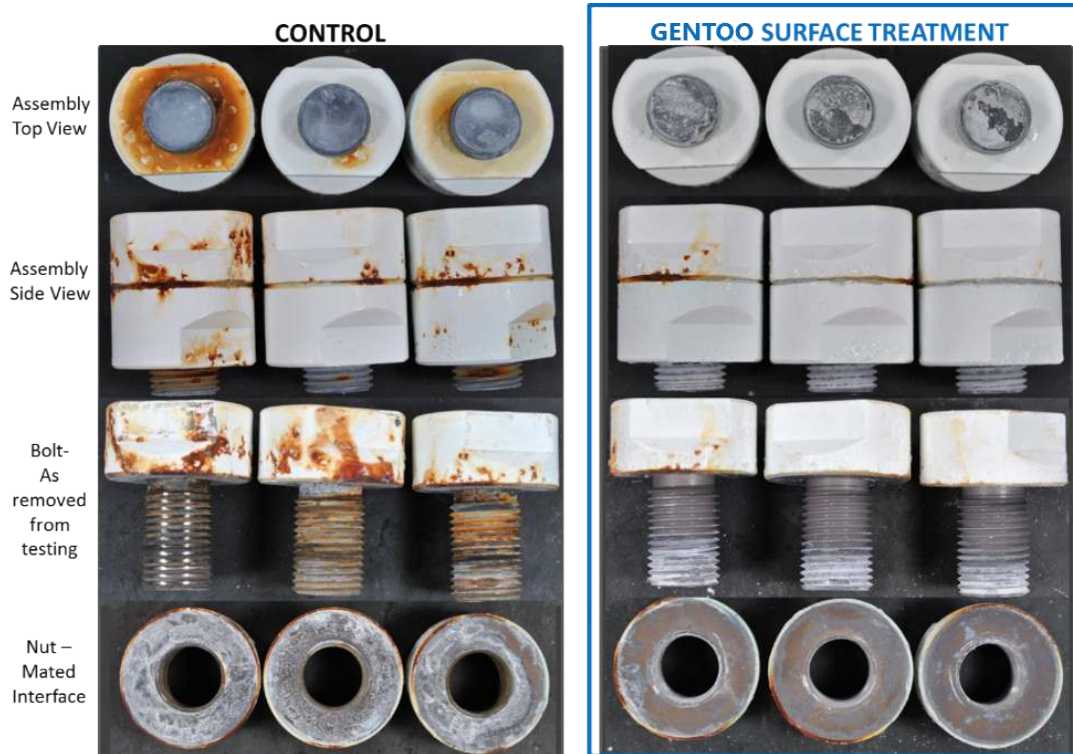
**Figure 16**

272 cycles of GMW14872 Exposure of control and Gentoo treated (blue box) LHE Zn-Ni 300M threaded components, as removed from testing

GMW 14872 exposure of the 300M threaded parts present similar results to those found following salt fog exposure. Figure 16 through Figure 18 show the control and Gentoo treated parts after 272 cycles (6528 h) of GMW 14872 exposure. The parts were finally removed from testing due to the presence of red rust on the exposed threads of the control samples. Both control and Gentoo treated threads had white product accumulated on the exposed threads. The white product was unable to be removed by washing or wiping from the control samples and was a product of LHE ZnNi consumption. The white spots on the Gentoo surface, however, could be rinsed off with water, as displayed on the tips of the threads in Figure 17, or removed with a gentle wipe. During GMW 14872 testing, there are a series of salt sprays during ambient conditions. Due to the hydrophobic nature of Gentoo, the spray beads up on the surface of the exposed threads. When the water evaporates, it deposits the salt behind, providing a site for further sprays to build up and deposit along. Despite the salt build-up, Gentoo continues to provide an excellent barrier from the corrosion inducing material and the LHE ZnNi and underlying 300M HSS is unaffected. The excellent protection provided by the Gentoo treatment is also evident on the unexposed threads of the bolt and nuts. The Gentoo treated parts are shiny, grey and pristine, while the control parts are dark and contain many areas with red rust.

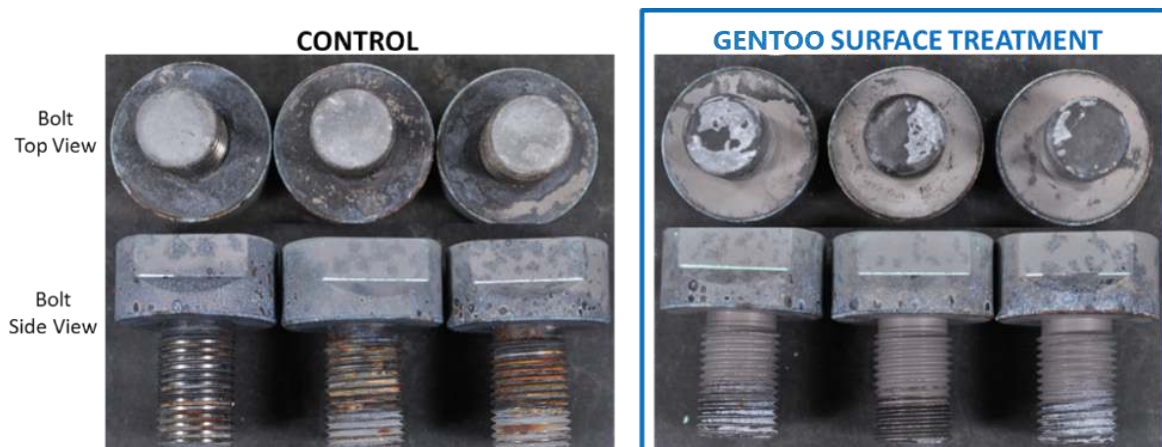
**Figure 17**

Plastic media stripped control and Gentoo treated (blue box) LHE Zn-Ni 300M bolts from 300M assemblies after 272 cycles of GMW14872 exposure

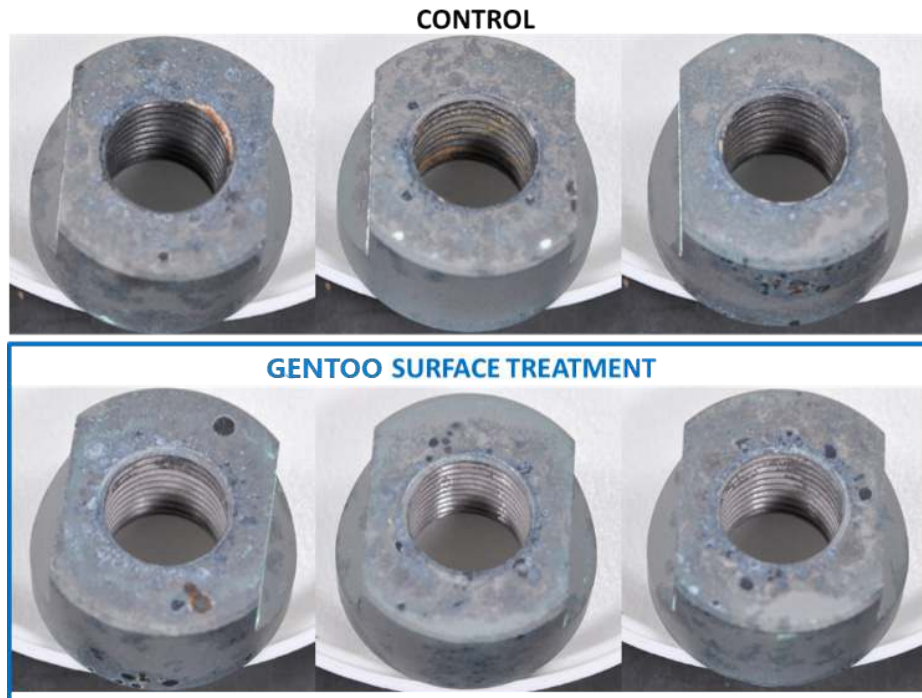
**Figure 18**

Plastic media stripped Control and Gentoo treated (blue box) LHE Zn-Ni 300M nuts from 300M assemblies after 272 cycles of GMW14872 exposure

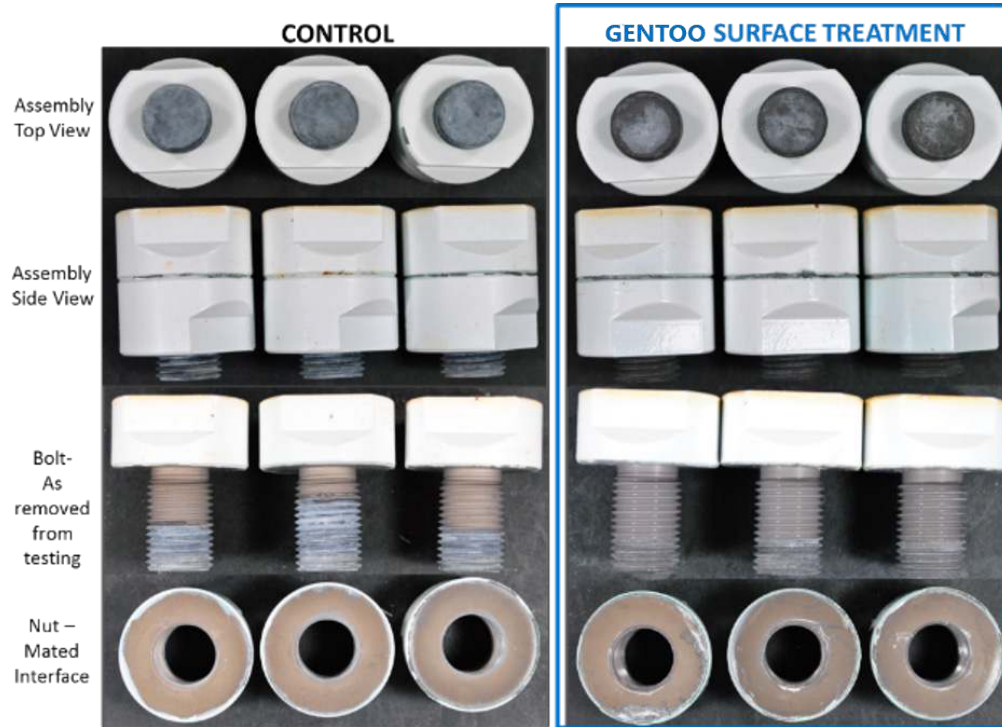
**Figure 19**

16 months of Kennedy Space Center, Florida beachside exposure of control and Gentoo treated (blue box) LHE Zn-Ni 300M threaded components, as removed from testing

Identical 300M threaded parts experienced 16 months of atmospheric exposure at Kennedy Space Center, Florida beachside. Images of the disassembled parts are displayed in Figure 19 and Figure 20. The exposed threads of the control assemblies show white LHE ZnNi consumption on the top and sides of the threads, while the Gentoo threads display minimal LHE ZnNi consumption. The inner threads of the Gentoo bolts are shiny and unchanged, while LHE ZnNi consumption down the threads toward the bolt head is obvious for the controls. Similarly, the inner threads of the Gentoo treated nuts are unaltered, while LHE ZnNi consumption is observed in the control threads.

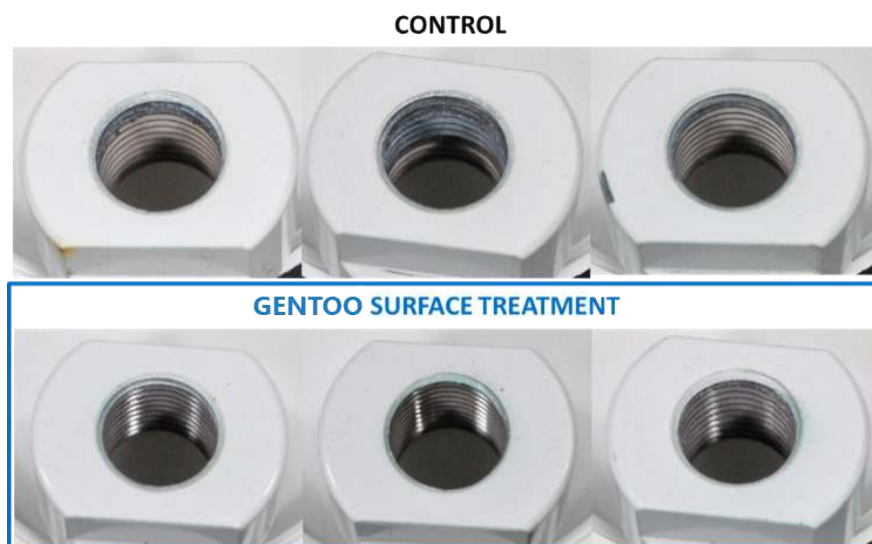
**Figure 20**

Control and Gentoo treated (blue box) LHE Zn-Ni 300M nuts with a view of inner threads from 300M assemblies after 16 months of Kennedy Space Center, Florida beachside exposure
